Progress Update St Georges Island – Issue 9

14th September 2023

Balcony Remediation Works

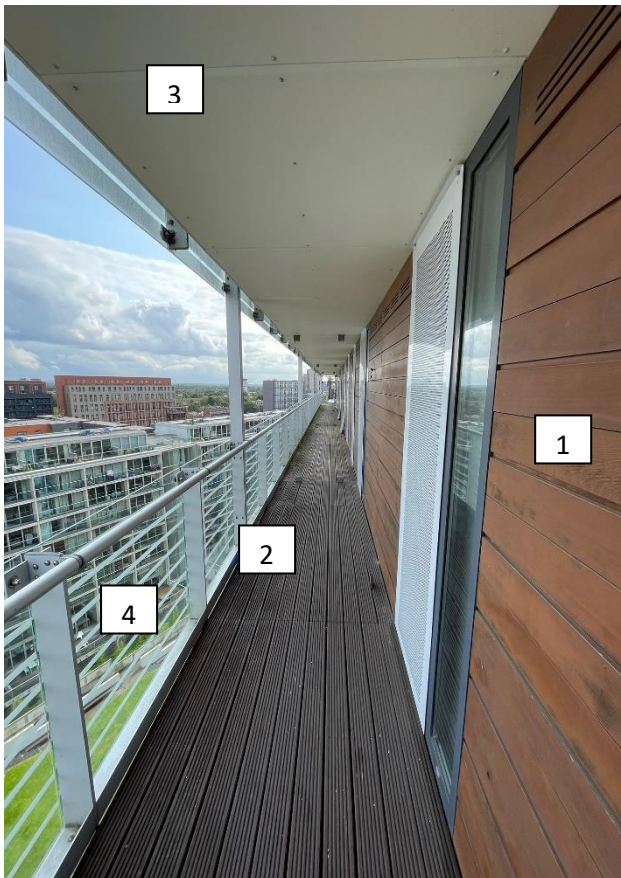
Existing Materials One

1. Cedar Wall Cladding
2. Timber Decking
3. Soffit Boards
4. Balustrade Glass

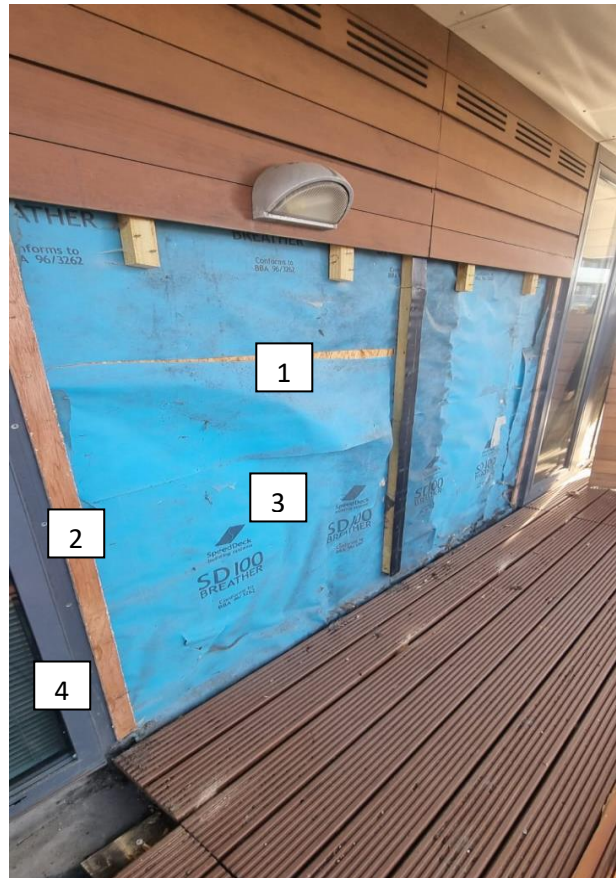
Existing Materials Two

The make-up of the existing cladding and internal materials of the balcony areas are shown below. In the photo titled Existing Materials Two, this shows the internal build-up of the SIPS panels and breather membrane currently used to insulate and control the condensation of the building. The SIPS Panels and timber battens are also used to support the existing cedar cladding. Timber battens shown in this photo, are fixed from the internal side of the apartment to the existing stud/partition walls of your apartment.

1. Breather Membrane
2. Timber Battens
3. SIPS Panel (behind the blue breather membrane)
4. Door/Window Frame

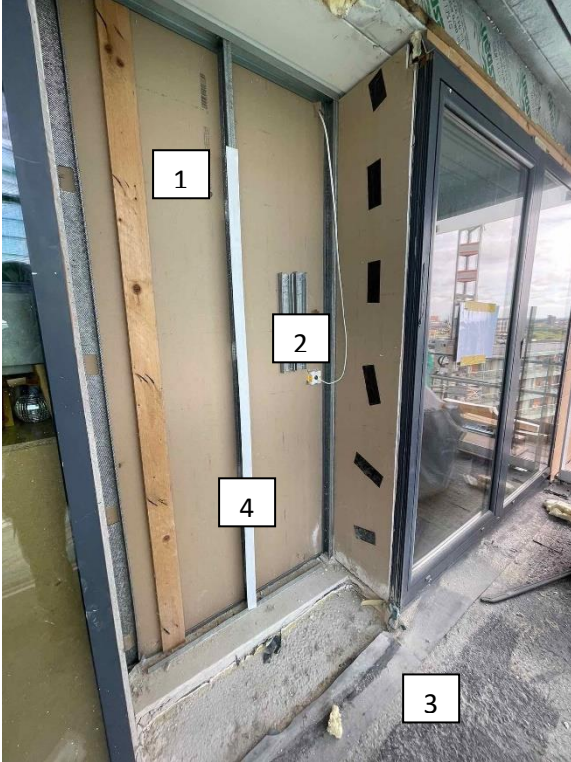
Existing Materials Three

The below photo titled Existing Materials 3, show where the cedar cladding, the breather membrane, SIPS Panel, and timber battens have been removed. Once all materials have been removed, you are left with the exposed internal plasterboard where any electrical fixings or wiring for items such as electrical sockets, wiring for balcony lights or vents will be located. The photo titled Existing Materials 4 shows a section of the SIPS panel cut out.

1. Plasterboard Internal Wall
2. Electrical Socket
3. Concrete Balcony Floor Slab
- 4 Plasterboard Framework

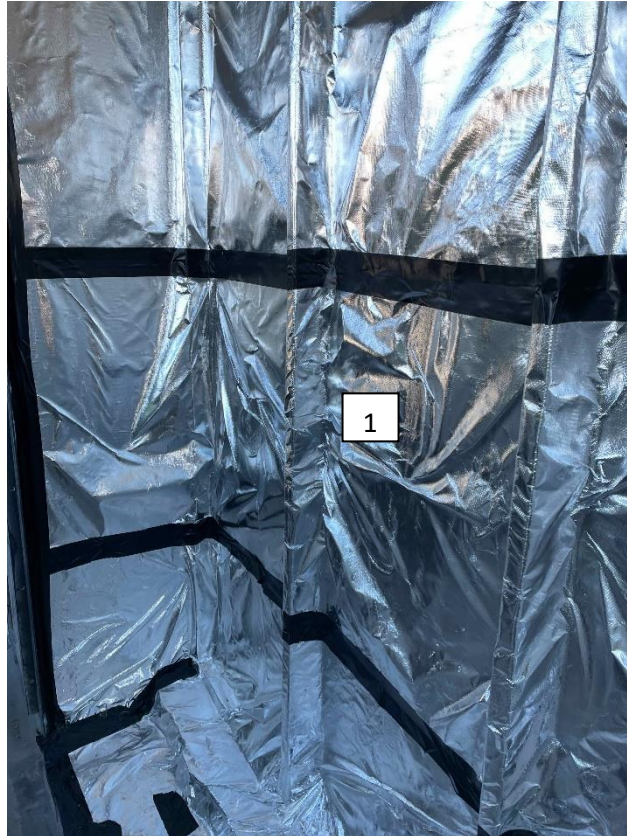
Replacement Materials One

1. VCL – Vapour Control Layer

As shown in the photos under section; Balcony Areas – Existing Materials, once all the existing materials have been removed, this then exposes the internal plasterboard to your home. Works will then begin to encapsulate and fireproof the area and immediately followed by the installation of VCL – Vapour Control Layer.

Any areas where existing materials have been removed will have the VCL installed on the same day to protect and weatherproof your home.

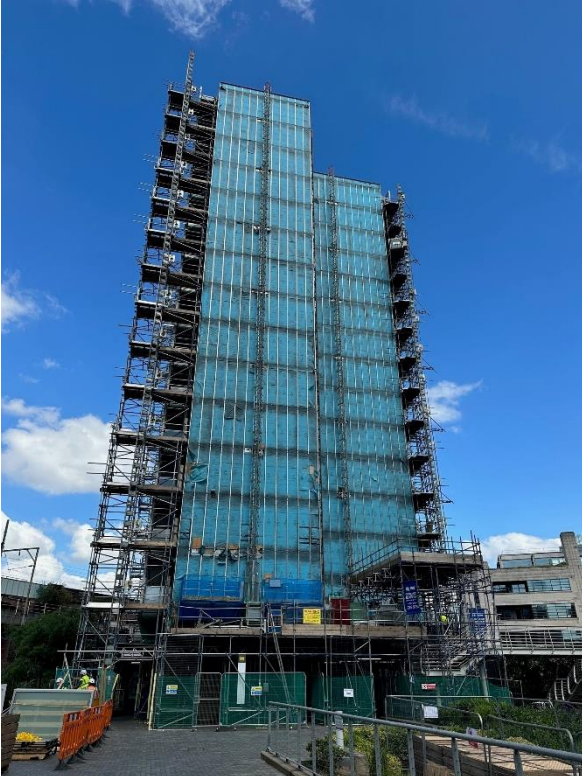
The above photo shows the South Elevation of Block 1 before removal works began. On this photo, the Terracotta Tile has been removed revealing the blue breather membrane.

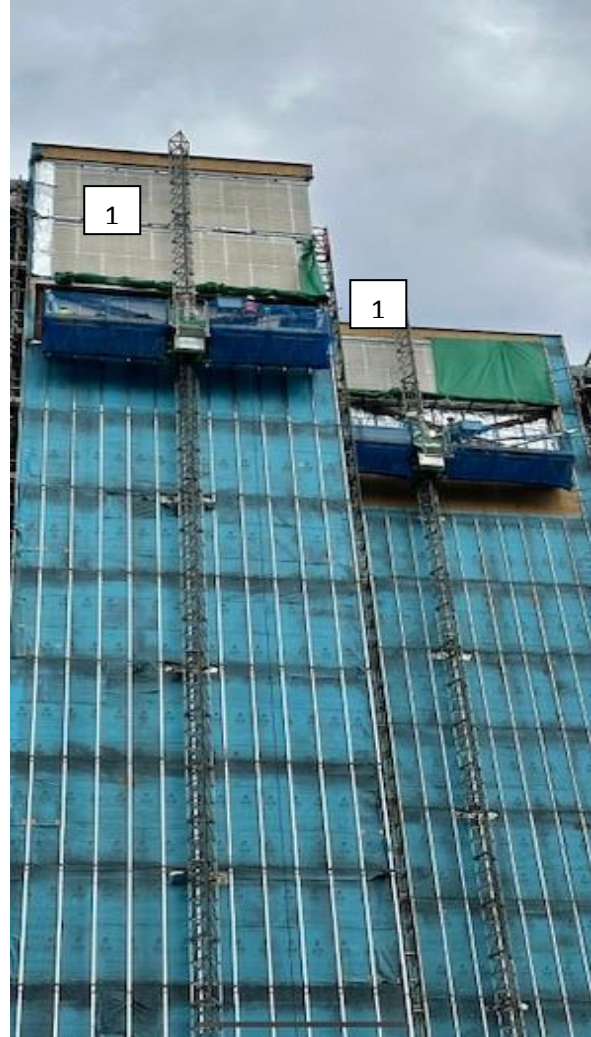
The above photo was taken 13/09/2023 and shows the progress of the works. Location 1 indicates the areas where all existing materials have been removed, and the new materials installed.
